Plan – Infrastructure, Electrical Networks

L2-ELN-PLA-003

BUSHFIRE MITIGATION PLAN 2019-2022

Version: 9

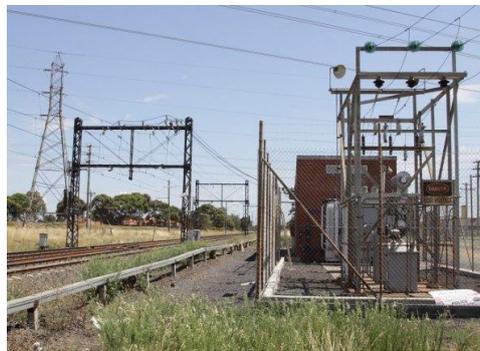
Figure 2 Rail Substation Switchyard and Steel Rail Structures - example only

Training requirement for Inspectors undertaking inspection of MTM Substation switchyards supporting overhead electrical lines in HBRA (MTM at-risk lines) is ESV approved UET20612 - Certificate II in ESI - Asset Inspection training which may include recognition of prior learning (RPL) by suitably registered training organizations(RTO), unless training otherwise approved by ESV.
