Plan – Infrastructure, Electrical Networks

L2-ELN-PLA-003

BUSHFIRE MITIGATION PLAN 2018-2021

BUSHFIRE MITIGATION PLAN 2018-2021	
L2-ELN-PLA-003	Version: 8	Effective from: 22 nd February 2019

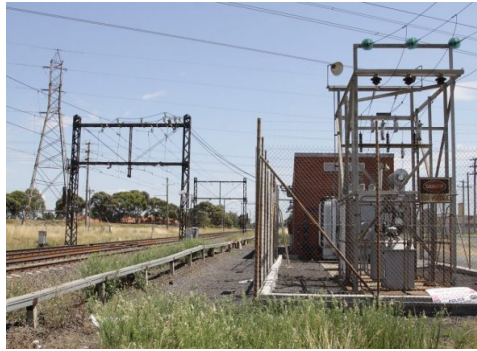
Training requirement for Inspectors undertaking inspection of MTM Substation switchyards supporting overhead electrical lines in HBRA (MTM at-risk lines) is ESV approved UET20612 - Certificate II in ESI - Asset Inspection training which may include recognition of prior learning (RPL) by suitably registered training organizations (RTO), unless training otherwise approved by ESV. With ESV agreed training defined in a MTM training plan submitted to ESV by February 2019.

Figure 2 Rail Substation Switchyard and Steel Rail Structures - example only

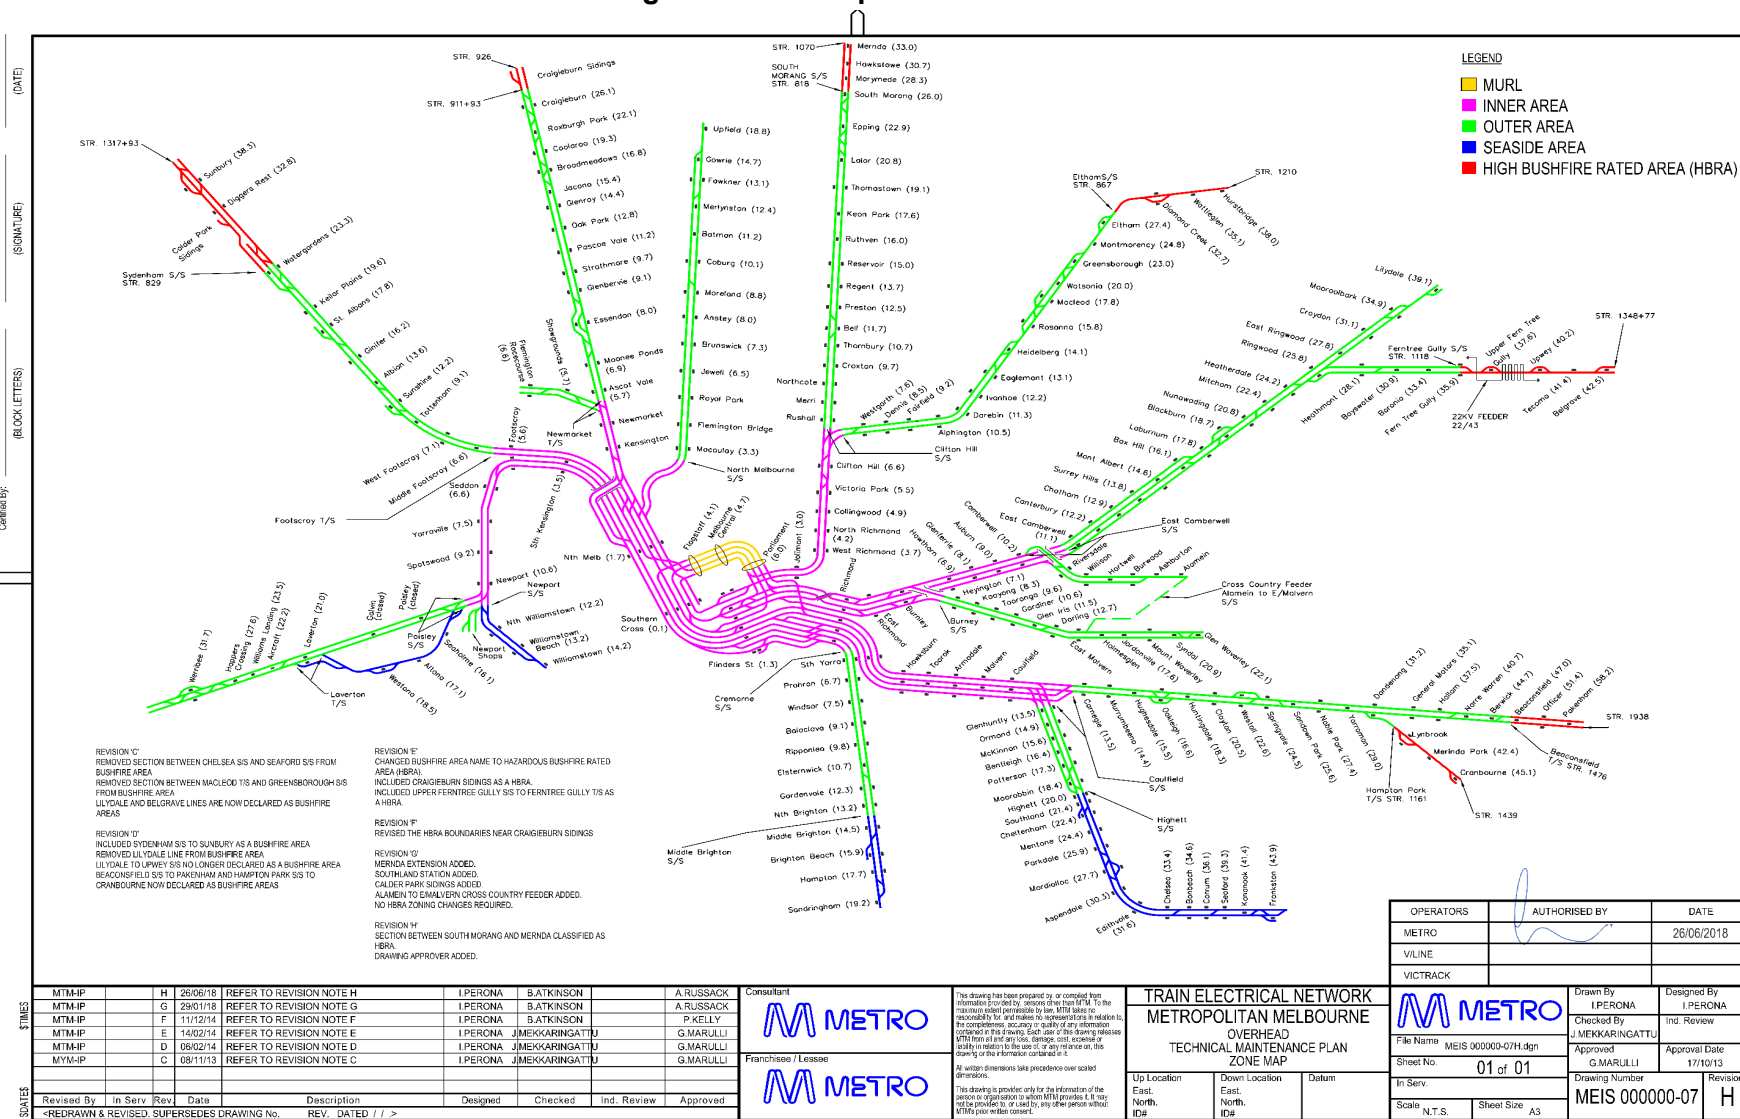
Appendix 4 - EN Information Sheet Overhead Wiring TMP Zone Map

This BMP scope is to ensure that the Electricity Safety Bushfire Mitigation Regulations are met with regards to MTM's at-risk electric lines. For the purposes of this Plan, 'at-risk electric lines' means all overhead electric lines under MTM control that are within CFA declared hazardous bushfire risk areas. The defined Hazardous Bushfire Risk Area covers approximately 51km of rail network managed by Metro as illustrated in Appendix 4.

The declared hazardous bushfire risk areas containing MTM Overhead Electrical assets were determined based on CFA maps that identify the Bushfire risk areas, the geographic representation of MTM assets in HBRA in relation to their location refer Appendix 4. A review in 2018 identified no changes in HBRA areas covering MTM Rail assets. Note: To mitigate the risk of the identification of specific assets in declared HBRA boundaries, the HBRA areas have been extended to the nearest rail Station or Electrical Substation structure in Appendix 4.
